Docket No. 217 – Development and Management Plan Inspection

Northeast Utilities Service Company Certificate of Environmental Compatibility and Public Need for the construction of a 345-kV electric transmission line and reconstruction of an existing 115-kV electric transmission line between Connecticut Light and Power Company's Plumtree Substation in Bethel, through the towns of Redding, Weston, and Wilton, and to the Norwalk Substation in Norwalk, Connecticut.

Date: August 3, 2006

Location: 115 kV Underground Route

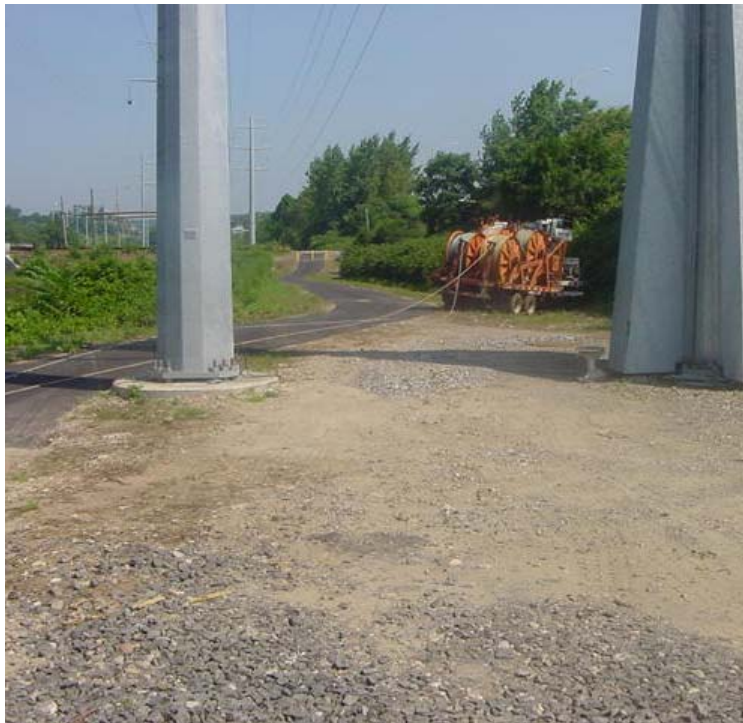
Photo on the left shows a view of the bike path on Broad St. Remove any remaining silt fence debris which is down within the vegetation and the restored areas. Photo on the right shows a washout remaining at the Bethel Ed Park near the south tower. Sediment had accumulated against the fence. 8/3/06

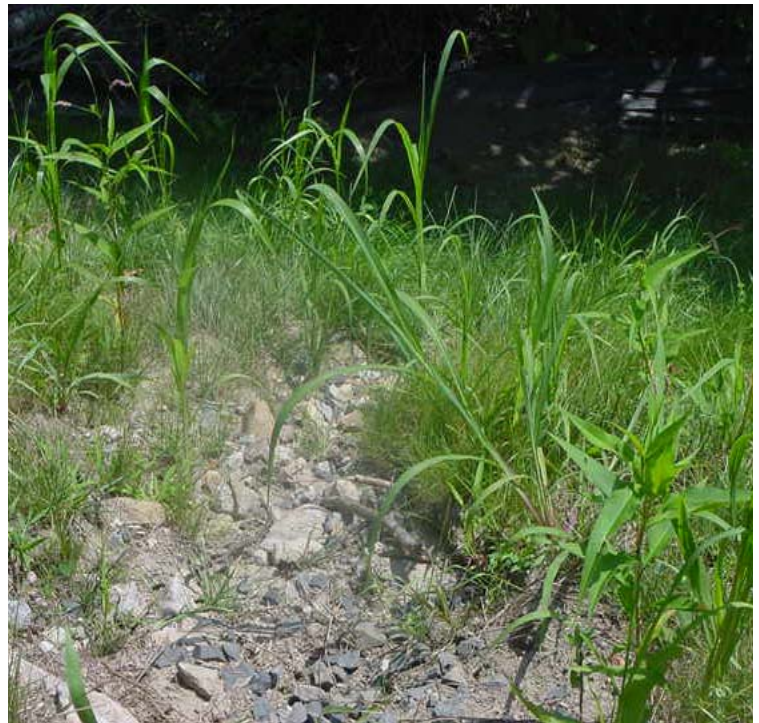
Areas of Inspection	Observation	Recommended Action	Corrective Action
Active Work Rt. 107, Redding	- Bethel Educational Park: - A piece of erosion control mat was to be installed on the southern slope but a small washout remains. 7/26-8/3/06	-See EC section. 8/3/06	-Still needs attention
	-Most roadside restoration appears complete. 8/3/06	- See EC section. 8/3/06	- N/A
Rt. 58, Bethel	-Restoration work was complete at the Hoyts Hill transition structure 8/3/06	-See EC section. 8/3/06	- N/A
Broad Street/ROW, Norwalk	-The restored areas adjacent to the bike path had some silt fence debris under the soil. 7/12-8/3/06	-Carefully remove all old silt fence and debris from this area. 7/12-8/3/06	-Needs attention
Main Ave. / Rt. 7, Norwalk	-None at this time. 8/3/06	-None at this time. 8/3/06	-N/A
Erosion and Sediment Controls Bethel Education Park Route 58	- One washout remains at the slope of the BEP south tower where sediment is building up at the fence. 7/19-8/3/06	- Repair the washout as well. 8/3/06	- Erosion control mats will be used

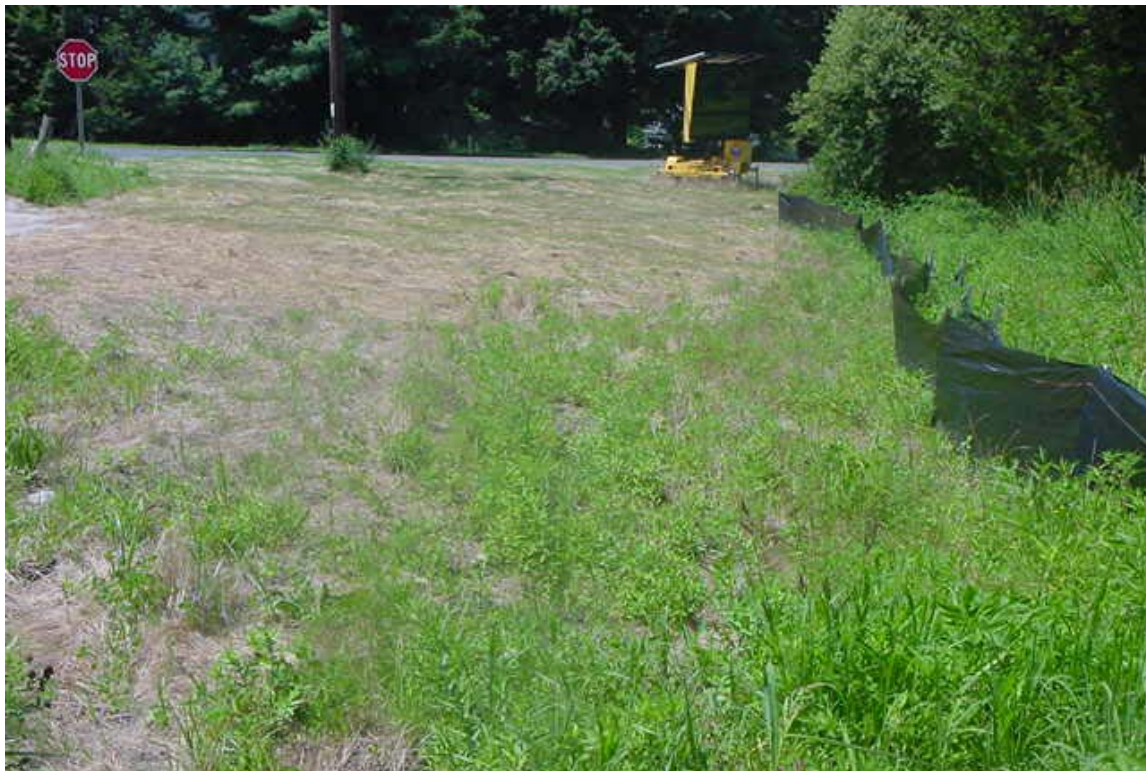
- At Sunset Hill Rd. vegetative growth continues at the mats. 8/3/06 - The Redding CC storage area stone surface remains stable and controls are in good shape. 8/3/06	- The entire area is now well restored. Continue to monitor. 8/3/06 - None at this time. The area had been used for some additional parking but will be restored. 6/1-8/3/06	-N/A -N/A at this time
Soils	-No active soil disturbance is occurring. 8/3/06	- None. 8/3/06	-N/A
Adjacent Wetlands and Waterways	-All resource areas in the vicinity of the project are in good shape. 8/3/06	- None. 8/3/06	-N/A
Staging, Storage, and Parking Areas	-Most storage areas are now returned to the original landowner. 8/3/06	- The Sunset Hill storage area was further stabilized. Look into final status at the Redding CC area. 8/3/06	- Evaluate Redding CC area
Vegetative clearing or stabilization	- Most areas are quickly becoming stabilized with increased vegetative growth. 4/12-8/3/06	-Continue to monitor but areas look good. 8/3/06.	-N/A

Photo shows a view of the Sunset Hill Rd storage area. The recently restored area with the erosion control mats and seed and mulch continues to have increased vegetative growth. 8/3/06
